Advanced Troubleshooting Guide

Transmission Problem

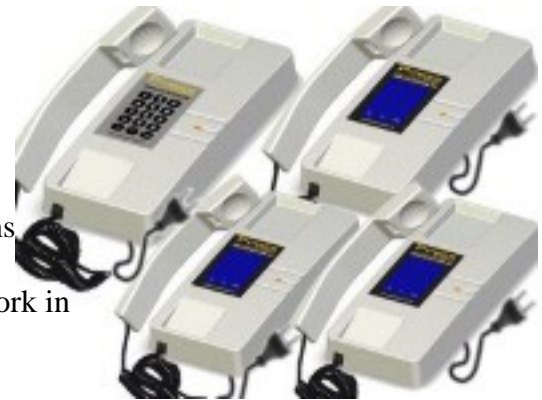
The common problem with multiple phases of electricity supply is the communication between units. The units might be communicating perfectly between the house & a detach garage 1000 feet away while having no communication at all within the same rooms or vice versa. There are also cases when the live leg of an upper receptacle and the live leg of a lower receptacle of a wall unit being wired in different phase of the AC supply. This is especially true in the kitchen area in houses that were wired before the 70's.

In a dual phase wiring situation, you can plug our all intercoms directly to 220V AC dual phase outlet. Then it will working in all two phases. Or you can use our earth wire intercom. It will also work in different phase line

All units transmit & receive by means of FM signal via the power lines. Therefore it is essential that all units are plugged in to the same phase of the circuit breaker or fuse.

Some big houses or older houses and most of the detached houses are wired with dual phase electricity. Especially family that uses electric range, electric cook top, electric wall oven, and electric dryers. Reason being all these electric guzzler appliances required huge amount of ampere (juice) to run. In a 110 volts AC environment, one 110 volts supply is not sufficient to handle the demand.
